Monterey HS Learning Community

July 21, 2010

Re: **Monterey High School**

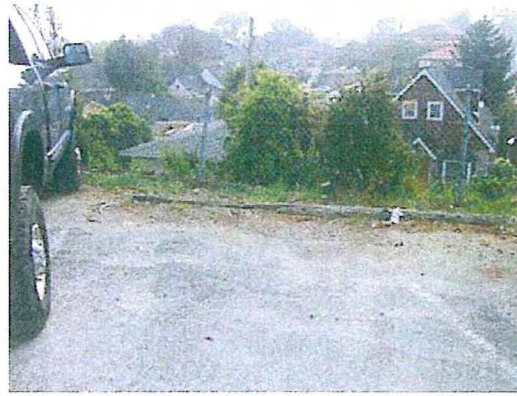
•Paving

Asphalt paving throughout the campus is deteriorated. New paving or resurfacing of existing is required, which will also give additional rejuvenation to the facility.

Reduction of impervious surfaces, and replacing with landscaping, will reduce some of the maintenance required for asphalt pavement.

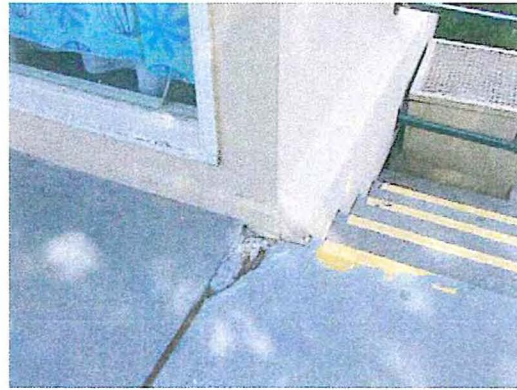
•Sidewalks

Most of the inner campus is paved with concrete with stairs and ramps. Some uplifting has occurred which creates water damage at buildings and expansion joints. Patch and repair all broken surfaces to create smooth transitions throughout the campus.

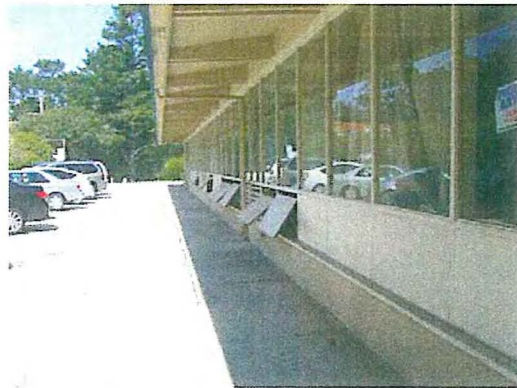
•Windows

The existing windows appear to have been replaced recently and are in relatively good condition. Patch areas of peeling paint and maintain all operable windows in working order.

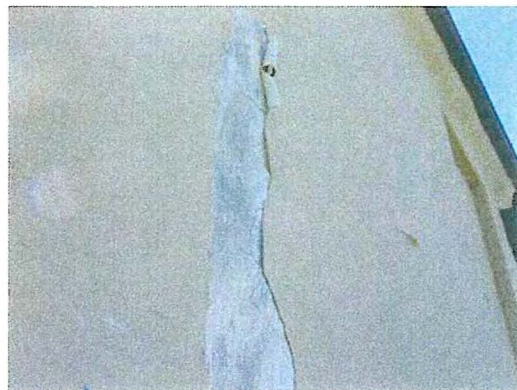
•Paint

Portions of the existing buildings are peeling or cracking and show signs of age. Provide new paint at all exterior walls, frames rails and overhangs.

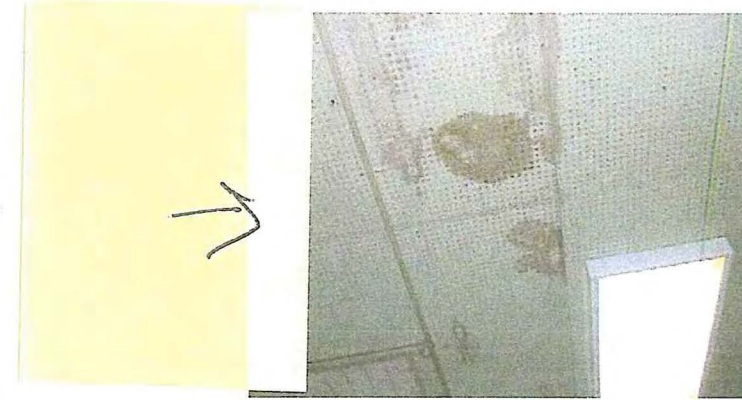
The existing perimeter fence is in poor condition and does not enclose the campus. To improve security and the safety of high school students, improve and provide perimeter fencing around entire campus.

Several buildings on campus have damaged or old ceilings due to water damage. Upon visual inspection, the roofs all buildings have been replaced recently however interior finishes have not. Provide new acoustical ceiling tiles and damaged areas throughout the campus.

Original boilers and heating equipment are failing to work properly and are causing discomfort for students and teachers. Provide new forced air mechanical heating units and allow for additional daylighting.

Upon visual inspection, the roofs of the facilities are relatively new and are in good condition. However skylights are broken and need replacement to prevent additional moisture into the building.

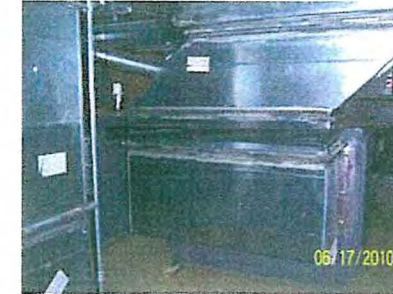
Figure 3: Replaced furnaces

This building has all ducted systems. There is a lower level and an upper level. The classrooms on the upper level are served by two furnaces (one for each side of the hallway). These furnaces have recently been replaced and are located in the lower level of the building. There is a third furnace that has recently been replaced that is also located in the same room. All ductwork looks original. These units are controlled by room thermostats (one per unit).

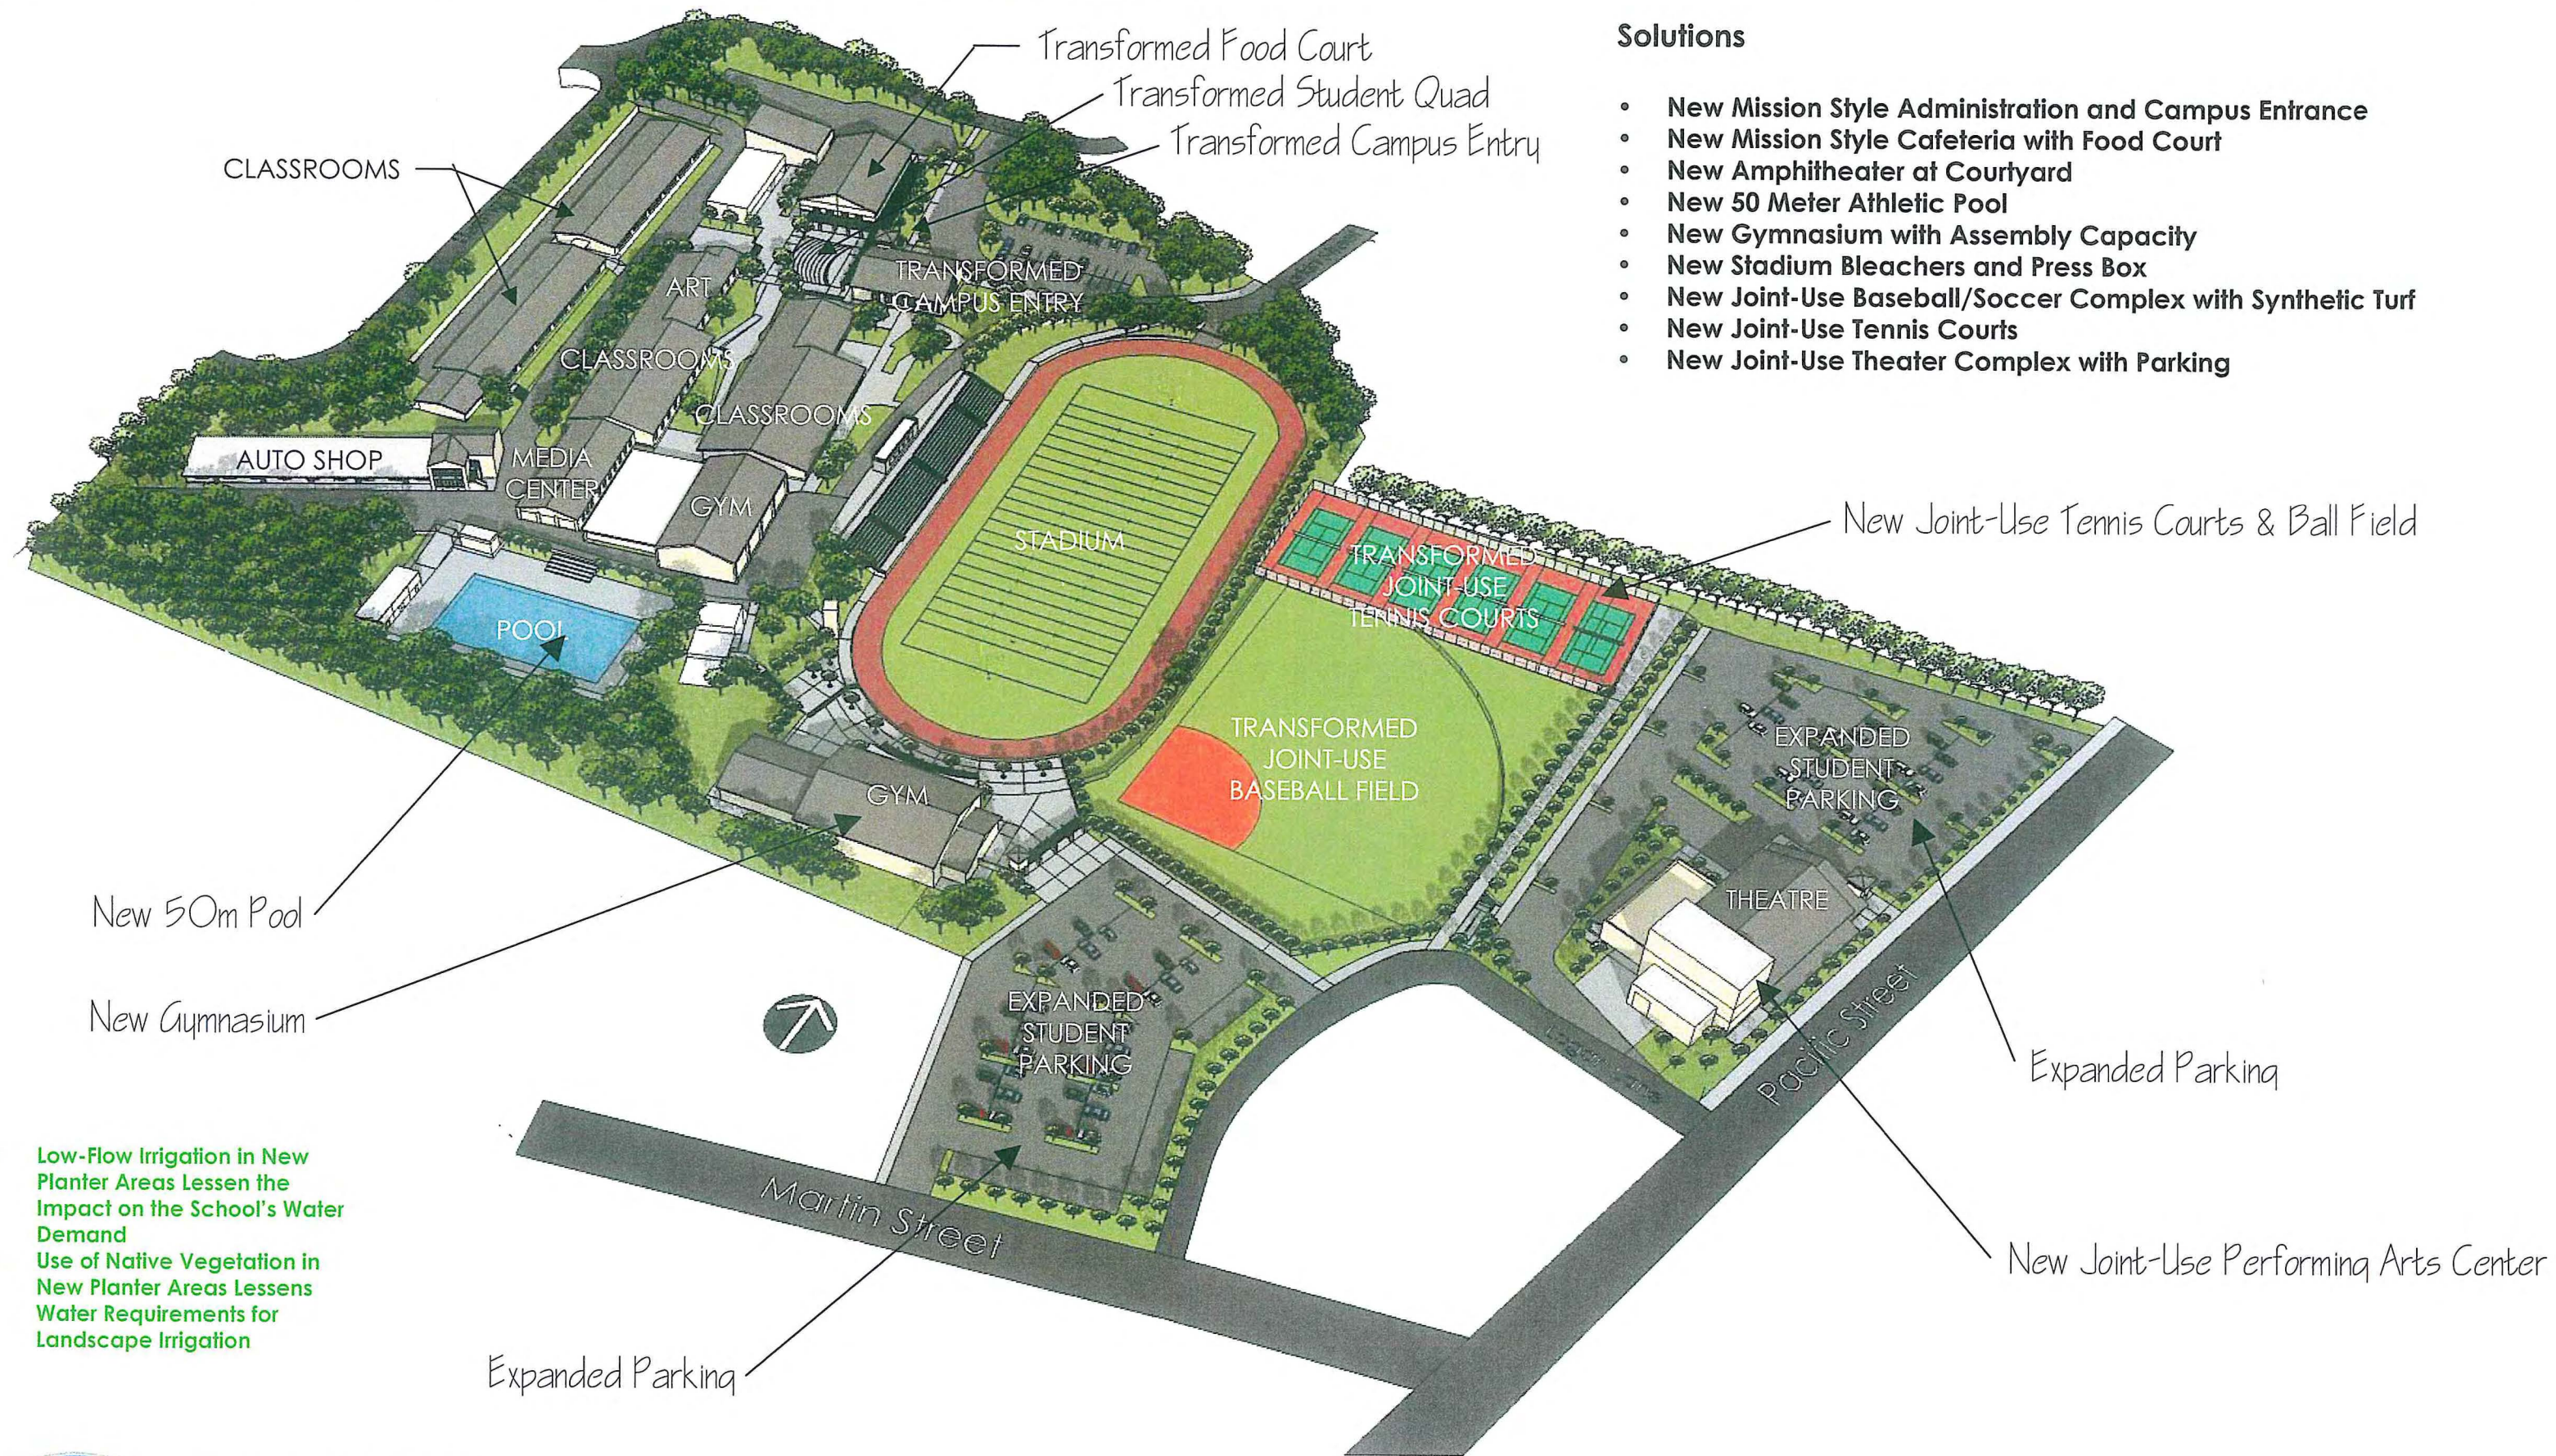
- New Mission Style Administration and Campus Entrance
- New Mission Style Cafeteria with Food Court
- New Amphitheater at Courtyard
- New 50 Meter Athletic Pool
- New Gymnasium with Assembly Capacity
- New Stadium Bleachers and Press Box
- New Joint-Use Baseball/Soccer Complex with Synthetic Turf
- New Joint-Use Tennis Courts
- New Joint-Use Theater Complex with Parking

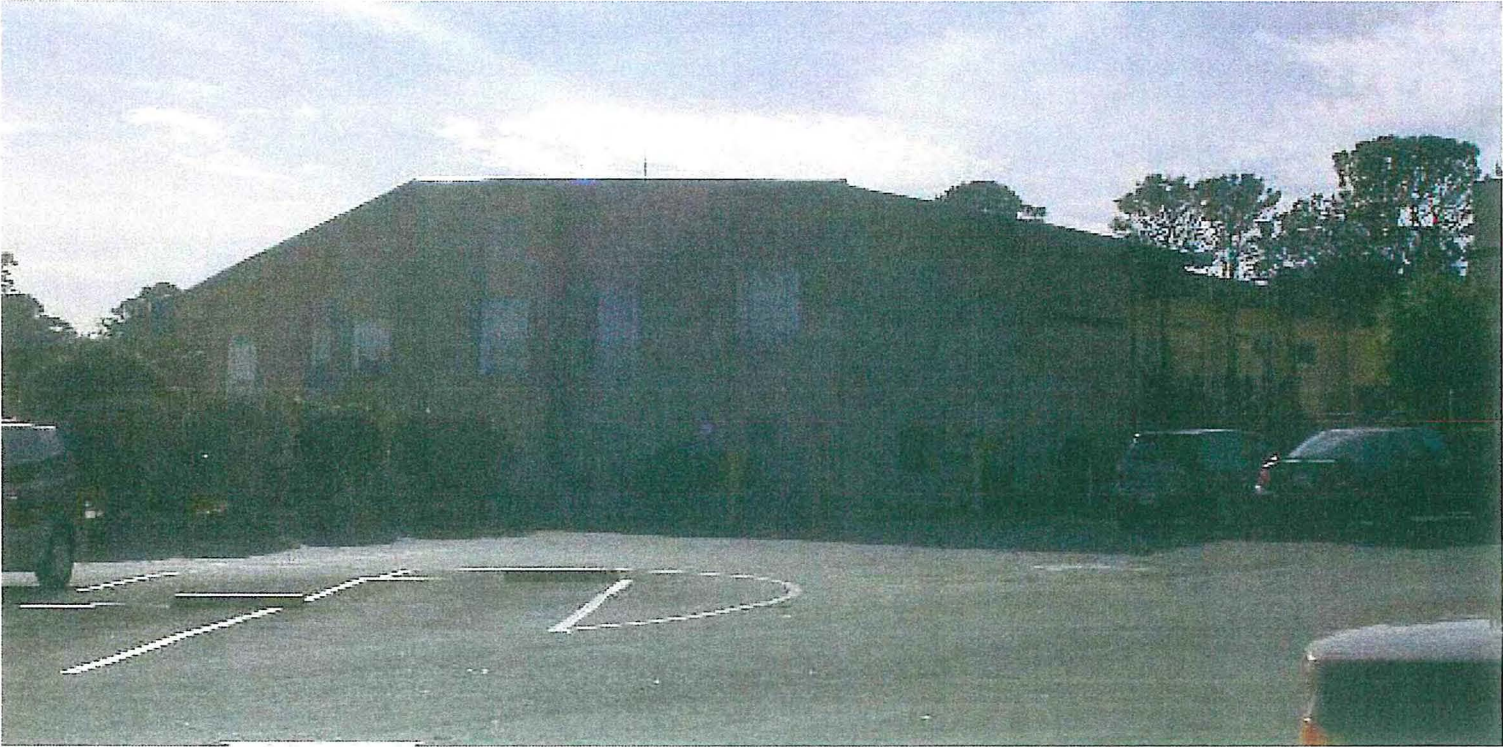
BEFORE: EXISTING ADMINISTRATION BUILDING AND ENTRANCE

The administration building does not address the entrance and is without any visual direction. Transform the administration into a focal point for the campus and create a pedestrian transition from the parking lot to main courtyard.

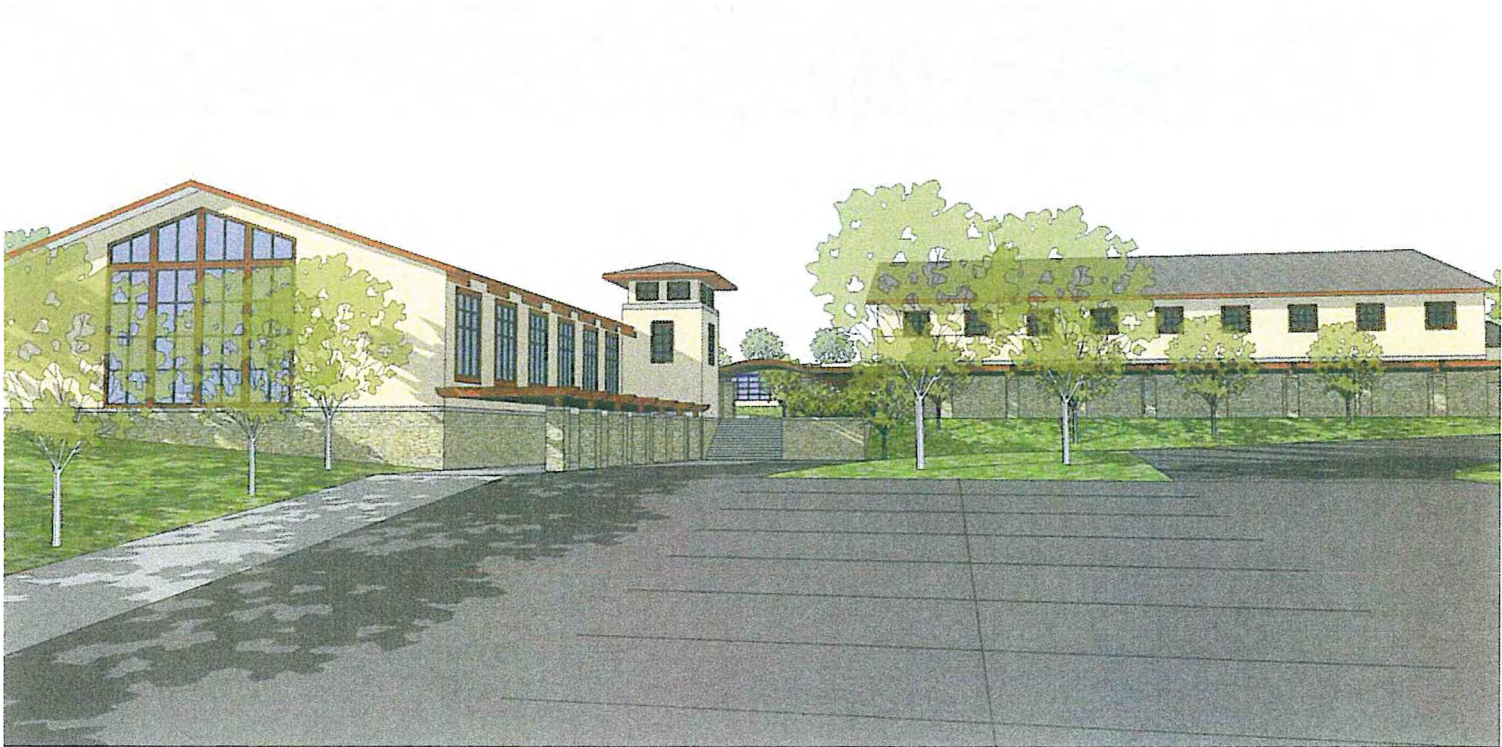
AFTER: TRANSFORMED CAMPUS ENTRY

The campus is currently without a formal entrance to transition users from the street to the administration building. Provide an architectural entrance and improve campus security at perimeter.
